Dr. Santosh Bhailume. Int. Journal of Engineering Research and Application ISSN: 2248-9622, Vol. 6, Issue 9, (Part -3) September 2016, pp.46-49

Monitoring Of Water Logged Areas in Krishana Canal Command Using Gis Techniques

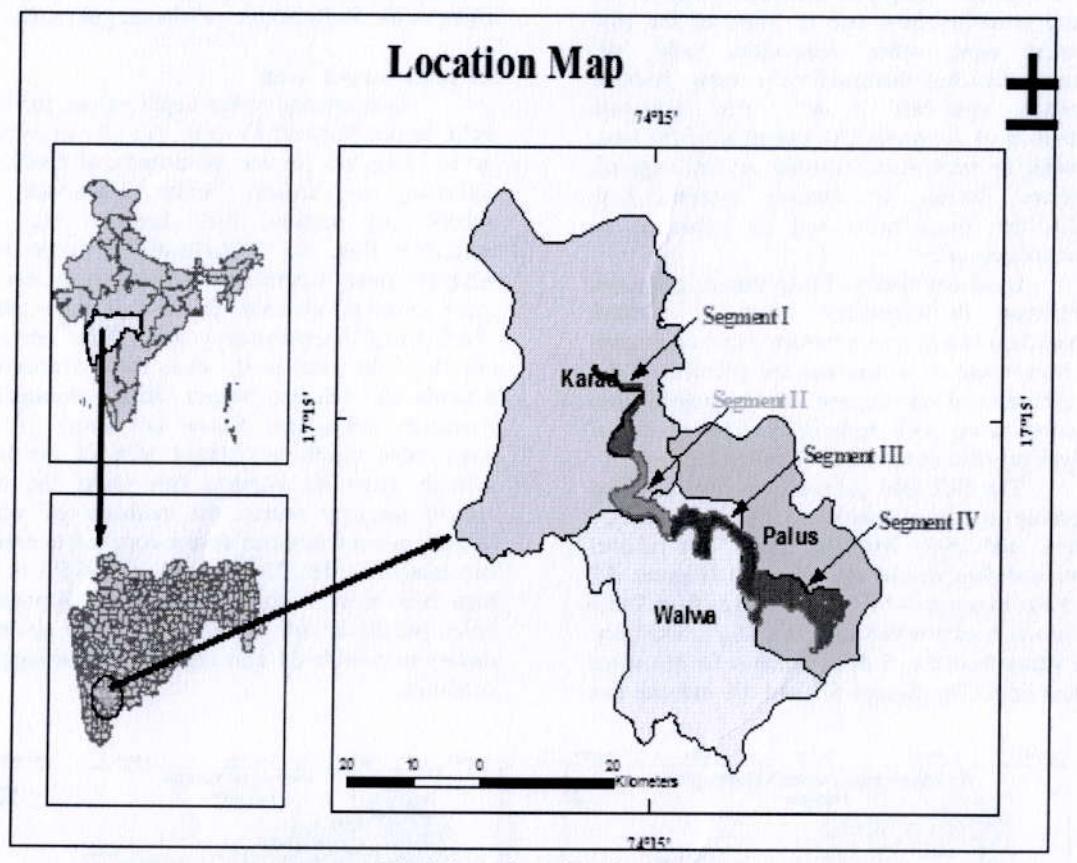
Fig.1- Location of study area

The study area lies between Krishna canal and Krishana River in Satara and Sangli districts of Maharashtra. The total length of the canal is 86 km running from Khodshi dam in Saidapur village to Yelavi village, covers 32 villages in Karad taluka of Satara district and two talukas namely walva and Palus in Sangli district. The Gross Command area is 15360 hectares. The command area is divided into four different segments. The present study deals with the segment IV lies between Krishna canal and Krishna River in Sangli district. The total length of segment is 21 km. Longitudinal and Latitudinal extent of the study area is from 74⁰ 16"

to 74[°] 23" East and 17[°] 03" to 17[°] 07" North respectively. The Study area includes eight villages

namely Nagral, Shirasgaon, Burli, Palus, Amnapur, Yelavi, Bhilawadi and Dudhondi.

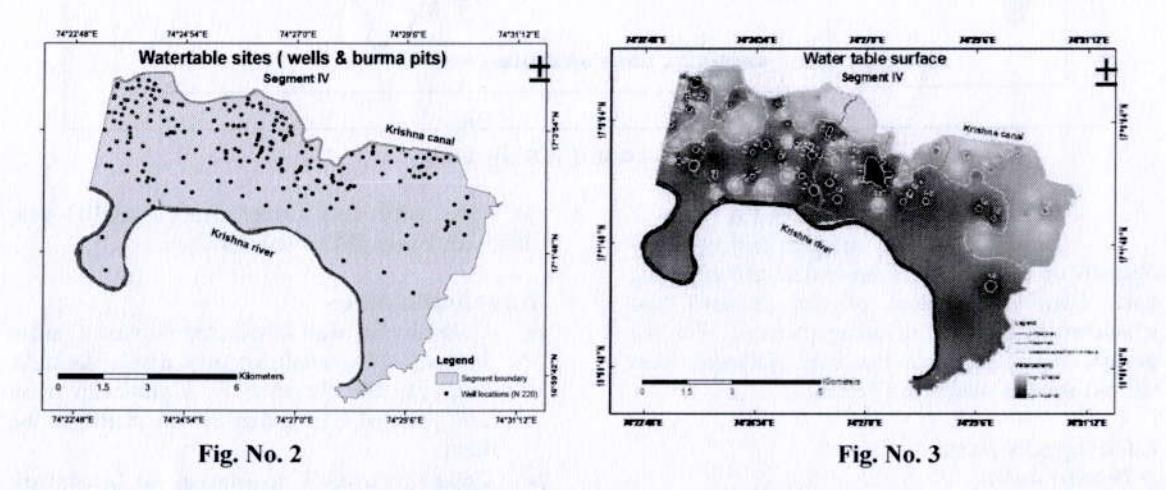
Interpolating water depth values for 231 wells in the Segment IV (Fig. No. 2), watertable surface (Fig. No. 3) was generated and classified according to critical limits mentioned in methodology section. Risk zonation map of watertable (Fig. No. 3) indicates that the two villages namely Nagral and Burli situated close to canal are most vulnerable due to high water table. The Coming to next category, almost 2200 hectares (36 % of the total study area) of land covering partially the villages Nagral, Burli, Shirasgaon, Amnapur, Palus, and Yelavi fall under critical water table condition. Almost 60% of the land partially from all villages falls under the less critical category where the problem of water logging is not that much severe compare to earlier two categories. The 264 hectares of land(5% of the total land) from villages Nagral, Burli, Amnapur, Palus and Bhilawadi having water table above 3 meters is considered non critical to waterlogging condition.

- Risk zonation map of watertable suggests that the two villages namely Nagral and Burli situated close to canal are most vulnerable due to high water table. Almost 2200 hectares (36 % of the total study area) of land covering partially the villages Nagral, Burli, Shirasgaon, Amnapur, Palus, and Yelavi were found under critical water table condition.
